# 检测报告

YNZKBG20220304004-2

大理丰顺医疗废物处置有限公司 2022 年 2 月份暨第一季度自行监测

大理丰顺医疗废物处置有限公司

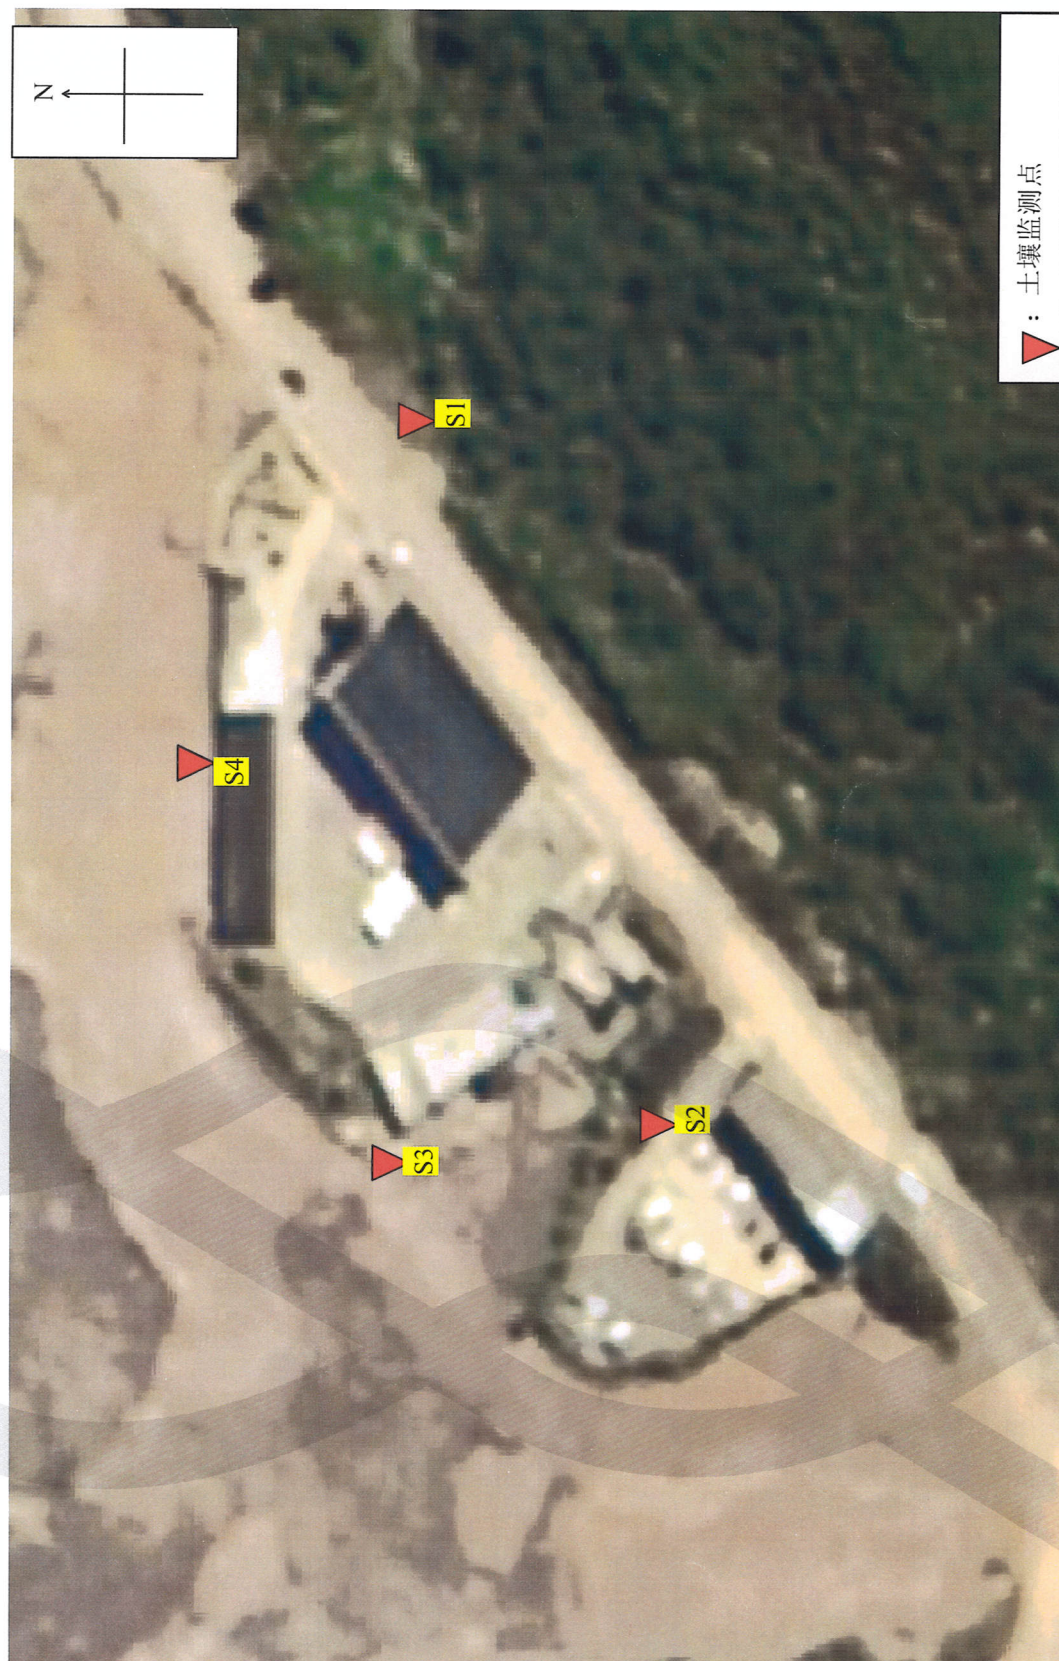
大理丰顺医疗废物处置有限公司 2022 年 2 月份暨第一季度自行监测点位图

| 客户基本情况 | | | | | | | | | | |
|---|---|---|---|---|---|---|---|---|---|---|
| 土壤 | 土壤 | S1: 厂界东侧<br>(E100°16'5.39", N25°31'31.97") | 1 | 1 | 熊瑞<br>李雄磊 | 2022.02.11 | 吕梦林 | 2022.02.12 | 2022.02.12-<br>2022.02.22 | 样品为黄棕色、湿、<br>少量根系、轻壤土。 |
| | | S2: 厂界南侧<br>(E100°16'2.48", N25°31'30.79") | | | | | | | | 样品为黄棕色、湿、<br>少量根系、轻壤土。 |
| | | S3: 厂界西侧<br>(E100°16'2.42", N25°31'32.18") | | | | | | | | 样品为红棕色、湿、<br>无根系、中壤土。 |
| | | S4: 厂界北侧<br>(E100°16'4.10", N25°31'32.96") | | | | | | | | 样品为黄棕色、潮、<br>无根系、砂壤土。 |
